# Product Change Notification

Product Change Notification: P-26-030969

## ISL Lock position low resistance

# MALE HSG / ISL FIT IMPROVEMENT

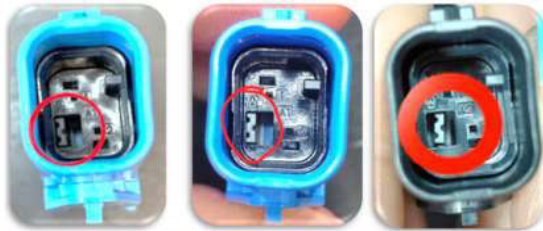
During SL inspection, multiple cases of unexpected lock activation were identified, showing an approx. 1.5% fallout rate associated with this failure mode.

An initial evaluation identified a noticeable gap between the housing and the ISL. A rattle effect is present, indicating excessive clearance between mating components. This condition may be contributing to the unwanted lock activation.

| Task | Responsible | Description | Target Date | Actual Completion Date |
|---|---|---|---|---|
| Corrective Action Identified | 1) Paul R.<br>2) Paul R.<br><br>2.1) Paul<br>3 & 3.1) Donnet<br>4) Zoran / Paul | 1) Initial Design change proposal required to increase bumps to improve interface<br>2) Lab analysis to confirm if the retention is adequate + Share recommended design changes to APMD<br>2.1) Final design Change proposal post-lab analysis.<br>3) Mold Tool design/Machining<br>3.1) Sampling<br>4) CT Scan report + PE Analys of samples | 1) 4/22/26<br>2) 5/13/26<br><br>2.1) Est. 7/22/26<br>3) Est. 7/31/26<br>3.1) Est. 8/3/26<br>4) Est. 8/14/26 | 1) 4/22/26 – Closed<br>2) 5/13/26 – Closed<br><br>2.1) Complete<br>3) Planned<br>3.1) Planned<br>4) Planned |

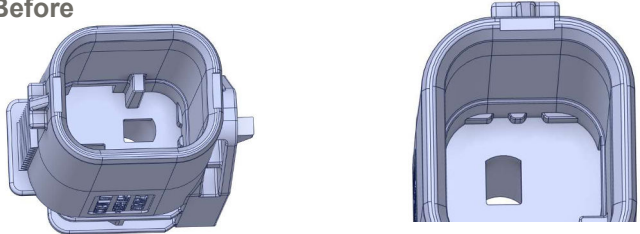
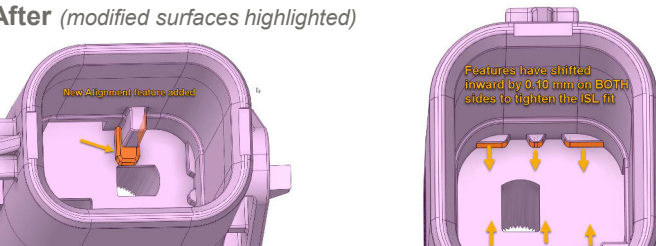
| CHANGE SUMMARY | BEFORE AND AFTER COMPARISON | CHANGE EXPLANATION |
|---|---|---|
| <ul style="list-style-type: none"> <li>Male Housing p/n 2482012 and ISL p/n 2482016 fit and alignment has been improved to eliminate any ISL shifting during shipping, prior to teminal installation.</li> </ul> | <p><b>Before</b></p> <p><b>After</b> (<i>modified surfaces highlighted</i>)</p> <p><i>Features have shifted inward by 0.10 mm on BOTH sides to tighten the ISL fit</i></p> | <ul style="list-style-type: none"> <li>To improve the fit and retention of the ISL during shipping, prior to terminal installation a lower alignment rib has been added in the housing that prevents the ISL from over rotation.</li> <li>The housings 2x ISL guiding side walls have also been tightened 0.10 mm per side to reduce overall ISL displacement and movement during transit.</li> </ul> |

To improve the fit and retention of the ISL during shipping, prior to terminal installation a lower alignment rib has been added in the housing that prevents the ISL from over rotation. The housings 2x ISL guiding side walls have also been tightened 0.10 mm per side to reduce overall ISL displacement and movement during transit.
