# Product Change Notification

Product Change Notification: P-26-030969

## ISL Lock position low resistance

# MALE HSG / ISL FIT IMPROVEMENT

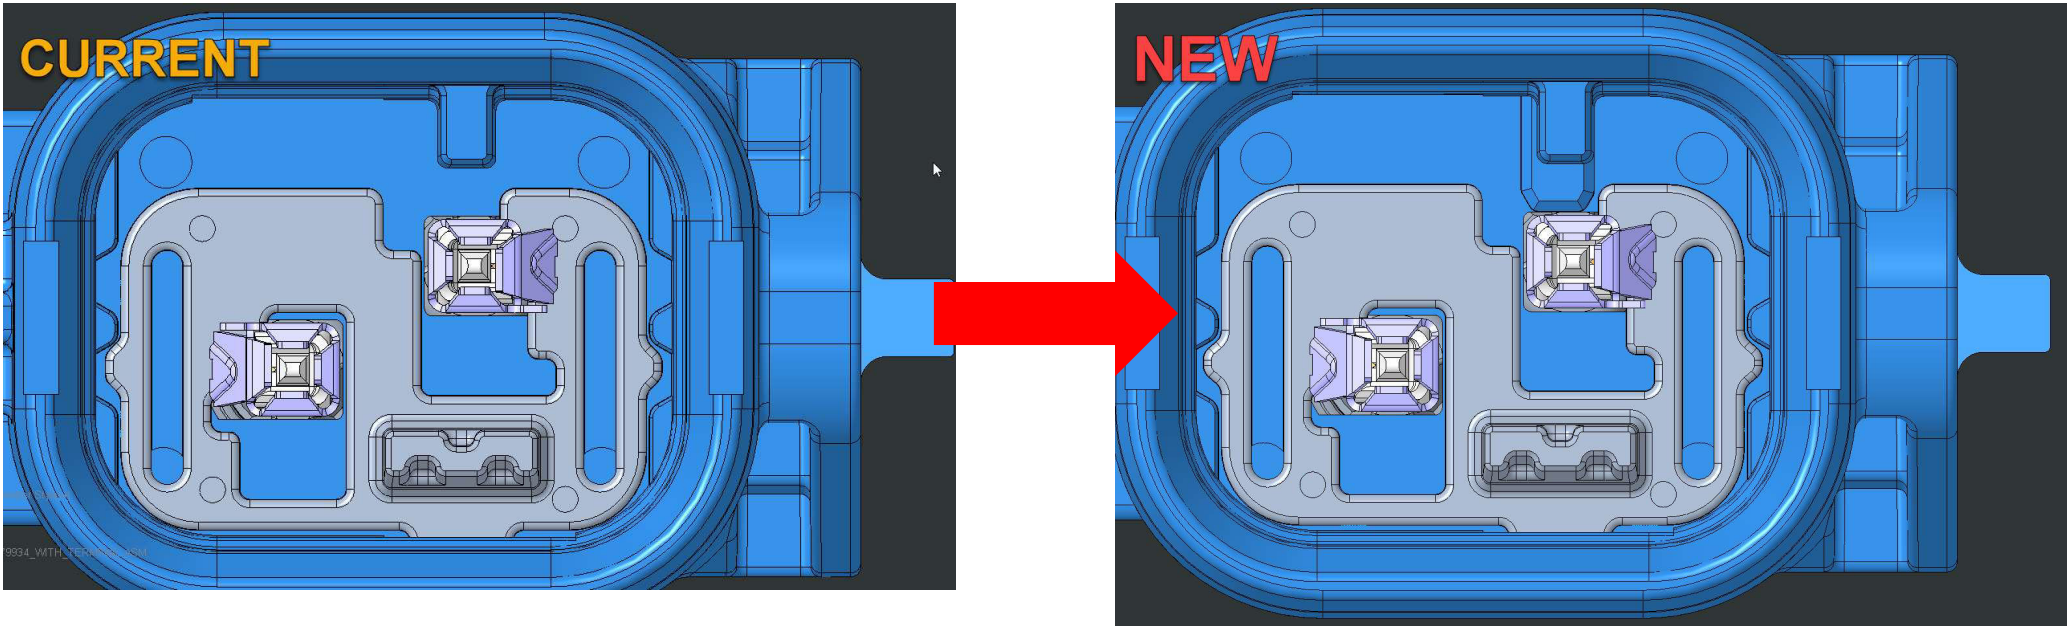
# ASSEMBLY 2479934

| CHANGE SUMMARY | BEFORE AND AFTER COMPARISON | CHANGE EXPLANATION |
|---|---|---|
| <ul style="list-style-type: none"> <li>Male Housing p/n 2482012 and ISL p/n 2482016 fit and alignment has been improved to eliminate any ISL shifting during shipping, prior to teminal installation.</li> </ul> | <div data-bbox="659 776 1436 1032"> <p><b>Before</b></p> <p>PREVIOUS REV CAD</p> </div> <div data-bbox="659 1036 1436 1297"> <p><b>After</b> <i>(modified surfaces highlighted)</i></p> <p>LATEST PDM CAD</p> </div> | <ul style="list-style-type: none"> <li>To improve the fit and retention of the ISL during shipping, prior to terminal installation, ISL detent angle has been changed to 49.4 deg.</li> <li>To improve the fit and retention of the ISL during shipping, prior to terminal installation, ISL detent engagement has been increased to 10.85 overall.</li> </ul> |
